**NATIONAL REGISTER OF HISTORIC PLACES
INVENTORY -- NOMINATION FORM**

Arrow Rock

1 No 82		4 Present Name(s) Edwin Barger Residence	
2 County S-line		5 Other Name(s)	
3 Location of Negatives Friends of Arrow Rock			
6 Specific Location Within a 30 acre tract .2 miles from the Jct of highway 41 and TT, bordered on the		16. Thematic Category	
7 City or Town if Rural, Township & Vicinity Arrow Rock		17 Date(s) or Period 1890's	
8 Site Plan with North Arrow

1 No 83		4 Present Name(s) Elmer Green Property	
2 County Saline		5 Other Name(s) William Lamb Residence	
3 Location of Negatives Friends of Arrow Rock			
6 Specific Location .2 miles E on TT from the Jct. of Hyways 41 and TT. The residence is bordered		16. Thematic Category	
7 City or Town If Rural, Township & Vicinity Arrow Rock vicinity		17 Date(s) or Period 1854	
8 Site Plan with North Arrow

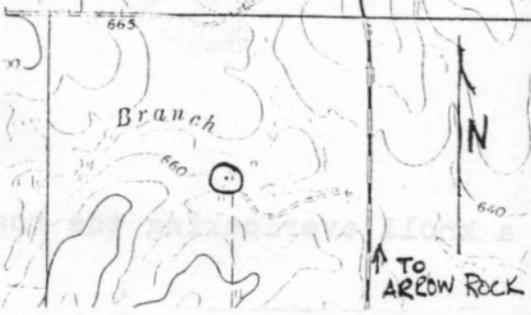
1 No 81		4 Present Name(s) Dr. William Price Summer/ Country Home	
2 County Saline		5 Other Name(s) Hogge Homeplace	
3 Location of Negatives Friends of Arrow Rock		Albert Hogge Residence, "Magnolia Vale"	
6 Specific Location 1.6 miles SW on Hyway TT from Jct 41 and TT., and 1/4 mile W of TT on dirt road		16. Thematic Category	28. No of Stories 2
7 City or Town if Rural, Township & Vicinity Arrow Rock		17 Date(s) or Period c 1855-57	29. Basement? Yes <input checked="" type="checkbox"/> partial under ell
8 Site Plan with North Arrow		18 Style or Design Federal/ Greek Revival	30. Foundation Material cut stone

44 Description of Environment and Outbuildings Several outbuildings are associated with the property but are well to the rear (S) of the structure and deal with the farm. One building, a small smokehouse with a pyrmidal roof, sits to the E of the house. The road now comes to the rear of the residence, but when the residence was built the

lights, and stone headers at the windows and doors. Built as a typical "I" house, the building has ornately corbeled chimneys at each end. Most windows are 6 over 6 and retain their original glass. There are matching mantels on the main level; wide woodwork and the wide plank floors are evidenced throughout the house. To reach the ell on the 2nd story level there is a door off of the main hall and one steps down into the ell. It should be noted that a log structure to the rear of the main brick block had to be removed to moved in the frame ell.

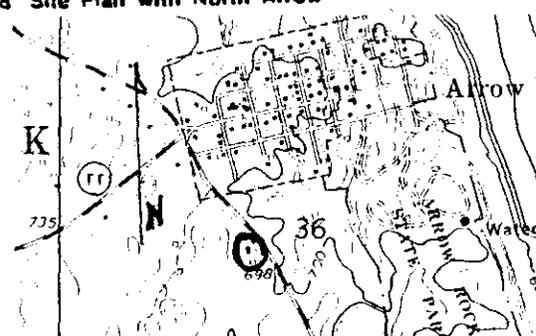
42. Further Description of Important Features Originally having fishscale shingles in the gables, the residence's exterior has been simplified, but retains its turn of the century feeling (see old Photo). Eastlake qualities can be found on the porch supports and frieze (Which has since been removed), and on the interior woodwork and large front facade window with transom which has small stained glass panels about its border. Addi-		26. Local Contact Person or Organization Friends of Arrow Rock c/o Richard Forry	
43 History and Significance Built as part of a prosperous farm complex the residence was owned for a period of time by the Brawve family, who added the west room where they boarded one of the local preachers. Significant as a prime example of the Queen Ann/Eastlake style built in rural communities.		27 Other Surveys in Which Included	
44 Description of Environment and Outbuildings Most outbuildings were present by 1946 when Barger's purchased the property. Four buildings remain in immediate proximity to the residence and include a gable roofed garage to the SW, a gable roofed shed to the S, a pent roofed		28. No. of Stories 1

30. Foundation Material stone	
		31. Wall Construction frame	
		32. Roof Type & Material gable, asphalt sh.	
		33. No. of Bays Front Side	
		34. Wall Treatment clapboard

37. Condition Interior good Exterior good	
		38. Preservation Underway? Yes <input type="checkbox"/> No <input type="checkbox"/>	
		39. Endangered? By What? Yes <input type="checkbox"/> No <input checked="" type="checkbox"/>

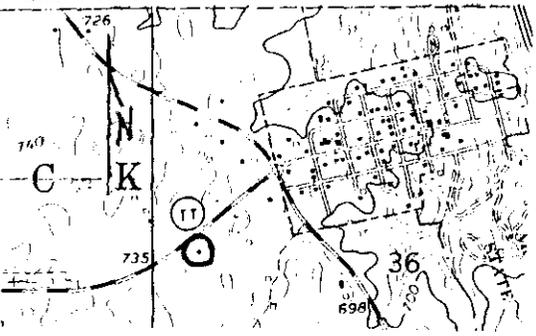
26. Local Contact Person or Organization Friends of Arrow Rock c/o Richard Forry	
		27 Other Surveys in Which Included	
42. Further Description of Important Features Ornate brick chimneys sit astride the ridge of each gable end. A projecting 2 story, pedimented portico 1 bay wide is flanked by 1 story uncovered porches. The central portico is set off by pilasters and with ship-lap. Four square columns support the porches at each level. The original ornately carved balustrade of wood has been replaced by molded concrete. Window surrounds		Photo	
43 History and Significance Built by William Lamb and sold by his heirs in 1872, the property served as a residence for a series of Arrow Rock merchants, T.C. Rainey, J.J. Tucker, and T.B. Morris. The building retains its architectural integrity, exemplifying a fine Greek Revival residence.			
44 Description of Environment and Outbuildings Sitting back from the road with a front yard of both soft and hard maples, the residence has several buildings associated with it: a non-conforming garage built of red clay tiles with a gable roof to the E and an original gable roofed smoke house with clapboarding to the rear (S). A well is to

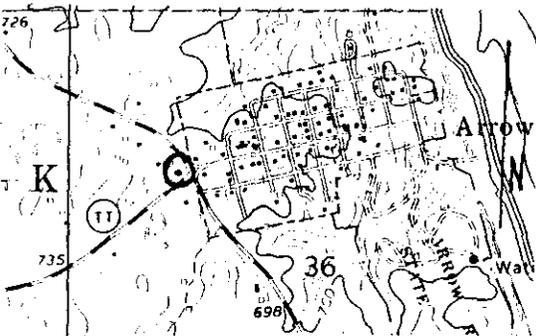
1 No. 84		4 Present Name(s) Art Ozias Residence	
2 County Saline		5 Other Name(s)	
3 Location of Negatives Friends of Arrow Rock			
6 Specific Location Located -.1 miles W of the Jct of Hyways 41 and TT on TT. Facing the Hyway the		16. Thematic Category	
7 City or Town If Rural, Township & Vicinity Arrow Rock vicinity		17 Date(s) or Period c. 1840's (?)	
8 Site Plan with North Arrow

42. Further Description of Important Features Presently sitting on moving equipment the house has been raised and moved forward while a basement is being dug. The structure will be replaced on its original location. Wide plank floors sit on a 6 x 8 sawn sill with 2 x 12 notched joist. Most of the siding was reworked or replaced and an addition to the ell is on the NE corner with a pent roof. The original ell has a gable roof.		26. Local Contact Person or Organization Friends of Arrow Rock c/o Richard Perry	
43 History and Significance Originally three small residences, similar in style and scale, set in a row along the hyway. This is the only one remaining. Being carefully restored, the building is a good example of preservation to a smaller residence for the community.		27 Other Surveys in Which Included	
44 Description of Environment and Outbuildings There are no outbuildings. The residence faces S to the Hyway,		28. No. of Stories 1

36. Changes (Explain in #42) Addition: <input checked="" type="checkbox"/> Altered: <input type="checkbox"/> Moved: <input type="checkbox"/>	
		37. Condition Interior good Exterior good

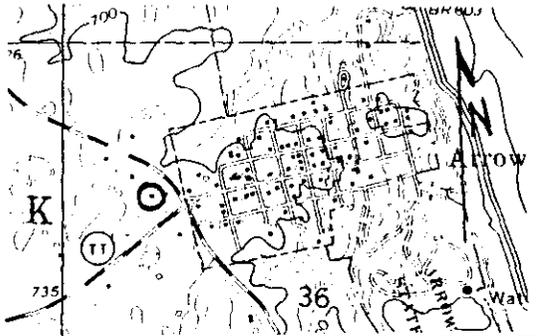
1 No. 85		4 Present Name(s) Pat Murphy Residence	
2 County Saline		5 Other Name(s) Methodist Parsonage	
3 Location of Negatives Friends of Arrow Rock			
6 Specific Location Located on Hyway 41, -.1 miles N. of Jct, 41 and TT on the W side of the Hyway.		16 Thematic Category	
7 City or Town If Rural, Township & Vicinity Arrow Rock vicinity		17 Date(s) or Period c. 1900	
8 Site Plan with North Arrow

44 Description of Environment and Outbuildings There are four outbuildings associated with the property but they do not fall within the boundaries for the nomination. There is a metal storage shed to the SE, a frame gable roofed garage to the W, a frame utility		28 No. of Stories 1 1/2	
45 Sources of Information Interview with Ms. Murphy, 5-79		29 Basement? Yes <input checked="" type="checkbox"/> No <input type="checkbox"/> partial	
		30 Foundation Material brick	
		31 Wall Construction frame	
		32 Roof Type & Material gable, asphalt sh.	
		33 No. of Bays Front Side	
		34 Wall Treatment vinyl siding	
		35 Plan Shape L	
		36 Changes (Explain in #42) Addition <input checked="" type="checkbox"/> Altered <input type="checkbox"/> Moved <input type="checkbox"/>	
		37 Condition Interior good Exterior good	
		38 Preservation Underway? Yes <input type="checkbox"/> No <input type="checkbox"/>	
		39 Endangered? By What? Yes <input type="checkbox"/> No <input checked="" type="checkbox"/>

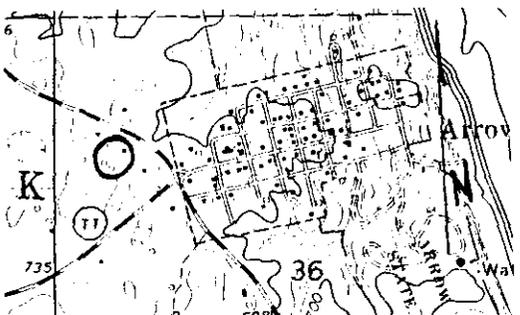
1. Num 85		4. Present Name(s) Bob Stith Residence and Farm Complex	
2. County Saline		5. Other Name(s)	
3. Location of Negatives Friends of Arrow Rock

15. Name of Established District		27. Other Surveys in Which Included	
42. Further Description of Important Features Classical affinities such as trabeated window surrounds, returns, a wide plain frieze, and raking cornice at the roof line and a transom and sidelights at the door, embellish the structure. Corner boards on the front facade are treated as pilasters. A raised front porch sits on molded concrete blocks and has a frame ballustrade with Doric(squat) columns. The central projecting bay forms a

44. Description of Environment and Outbuildings Sitting back away from the Hyway on a slight knoll, the residence has several farm outbuildings associated with it. See map. 1. a 10' x 12' smoke house with clapboarding, a gable roof with asphalt shingles over the original wooden ones, a 4-panel door, and a raking cornice. The clapboarding is over wide		46. Prepared by L. Harper

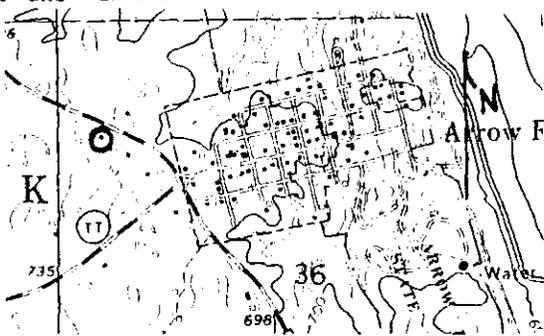
1 No 86		4 Present Name(s) Kenneth Eddy Home	
2 County Saline		5 Other Name(s) Plantation House Antiques, Evergreen Estate	
3 Location of Negatives Friends of Arrow Rock			
6 Specific Location Located .2 miles N of Jct 41 & TT on the W side of Hyway 41. The residence is		16. Thematic Category	
7 City or Town II Rural, Township & Vicinity Arrow Rock vicinity		17 Date(s) or Period c. 1858	
8 Site Plan with North Arrow

26. Local Contact Person or Organization Friends of Arrow Rock c/o Richard Forry	
		27 Other Surveys in Which Included	
42. Further Description of Important Features Combining the Greek Revival qualities of trabeated windows and door surrounds of transom and sidelights and Italianate motifs such as the low hip roof and the exterior covering which mocks a shallow rusticated stone and quions in frame siding, the residence has a central projecting, pedimented bay and brackets at the roof line. There are two ornately corbelled chimneys to each side of the central hall. Addi-		28. No. of Stories 2

29. Basement? Yes <input checked="" type="checkbox"/> No <input type="checkbox"/> cellar under kitchen	
		30. Foundation Material cut stone	
		31. Wall Construction frame

37. Condition Interior good Exterior fair	
		38. Preservation Underway? Yes <input type="checkbox"/> No <input type="checkbox"/>	
		39. Endangered? By What? Yes <input type="checkbox"/> No <input checked="" type="checkbox"/>

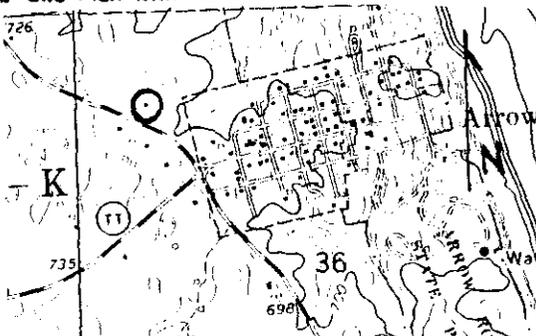
1. No. 87		4. Present Name(s) Henry Hogge Residence		1. No
2. County Saline		5. Other Name(s) Van Winter House, Blakely House		
3. Location of Negatives Friends of Arrow Rock

44. Description of Environment and Outbuildings Sitting back from the road, on a slight knoll, the residence has only one outbuilding within its nomination boundary. A small brick smokehouse sits to the rear of the residence. It has a 4-panel entrance door and a		30. Foundation Material field stone		5. Other Name(s)

covered structure which replaced the original 2 story ell to the rear. C. 1940 when Mrs. Blakely acquired the house, several changes were made; One fireplace mantel was replaced with marble from the Baltimore Hotel in K.C., closets flanking the fireplaces were removed and windows were put in, a door to the SE front room was added off the hall, put in hard wood floors, and added a bath and closet upstairs. In the SW gable end she added one window on each level. On the interior the woodwork is tra-beated with 4 panel doors through out. Note the door of the central hall to the SW room has arched top panels. An octagonal newel post complements the walnut stairs in the central hall. At the windows, the sills are approx. 14" deep and have tile inset into them. The basement under the main block of the house repeats the 1st floor plan. The millwork is heavy throughout and is repeated upstairs with transoms over the interior doors.

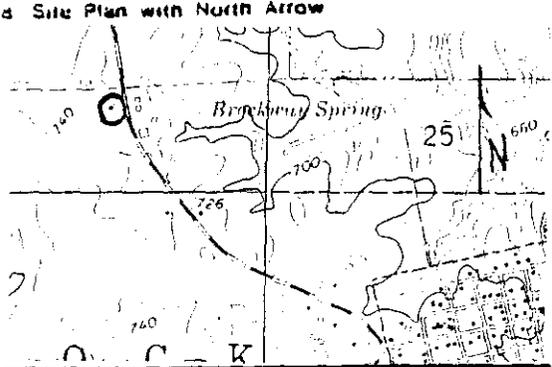
1 No 89 88		4 Present Name(s) Moseley Property	
2 County Saline		5 Other Name(s)	
3 Location of Negatives Friends of Arrow Rock		Brockway Property	
6 Specific Location Located on Hyway 41, .8 m. N of Jct 41 and TT on the W side of 41, the property		16. Thematic Category	
7 City or Town If Rural, Township & Vicinity Arrow Rock vicinity		17 Date(s) or Period 1910	
8 Site Plan with North Arrow

30. Foundation Material concrete	
		31. Wall Construction frame	
		32. Roof Type & Material gable, asphalt shi	
		33. No. of Bays Front 3 Side	
		34. Wall Treatment clapboard

37. Condition Interior good Exterior good	
		38. Preservation Underway? Yes <input type="checkbox"/> No <input type="checkbox"/>	
		39. Endangered? Yes <input checked="" type="checkbox"/> No <input type="checkbox"/> By What? empty - for sale

concrete piers. The porch has beaded narrow board ceiling and a heavily molded fascia with small brackets. A small window in the 2nd story pediment has a trabeated surround and is filled with stained glass. An interior chimney set to the N of the central hall is built of plain brick. On the S facade there is a 1 story bay window set on concrete piers. Corner boards at all corners are made to represent pilasters. Two flat roof additions to the rear appear to have been made immediately after the house was constructed as the trim matches the main block of the house. On the interior, one enters into a central hall with stairs leading to the 2nd story. Decorative motifs on the square knewel post match those on the front door. The rail and balusters are turned. The stairs are enclosed and are embellished with a panel motif below the stringer. Millwork is richly stained, trabeated; windows are attenuated, reaching to 1' from the floor and most are 1 over 1 with their original glass. The kitchen has been modernized as well as some ceilings lowered. An enclosed porch on the rear has extensive use of beaded panelling. All doors are 5 panel with the panels running horizontally; all the original door hardware is intact.

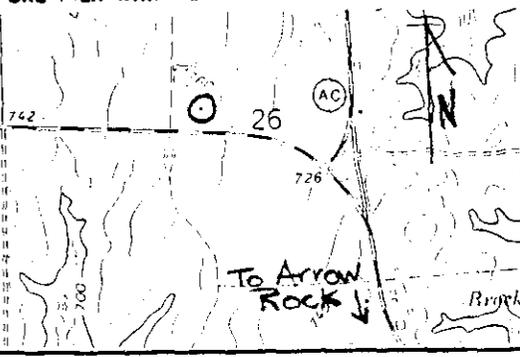
44. Description of Environment and Outbuildings Only one Chestnut tree remains from the grove in the front yard from which the residence drew its name. There are several outbuildings associated with the farm but they lie outside of the nomination boundary. Also outside of		30. Foundation Material stone

dows and the transom and sidelights of the two doors on the main facade are intact. The original two story ell to the NE has also been removed and replaced by a 1 story ell. The interior has not been carefully restored, the mantels no longer exist, except in one upstairs room (W). The original wide board floors do remain in the 2nd story; they sag quite visibly, due to the storage of wheat in these rooms (oral history). According to oral history the timbers for the structure were floated down the MO River to a point 1 mile E of the house.

Within the boundaries there is only one outbuilding, a small board and batten smoke house on stone piers and having a pyramidal roof. It sits to the N of the residence.

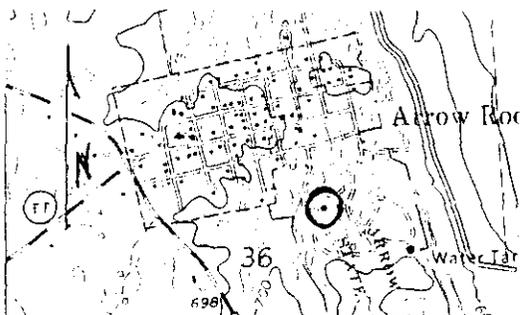
15. Name of Established District		25. Open to Public? Yes IX No II	
42. Further Description of Important Features The spring is now covered by a open pavilion measuring 10' x 10' with a stone foundation and pyramidal, wood shingled roof. It has been uncovered or with different types of access to the spring over the years.		26. Local Contact Person or Organization Friends of Arrow Rock c/o Richard Forry

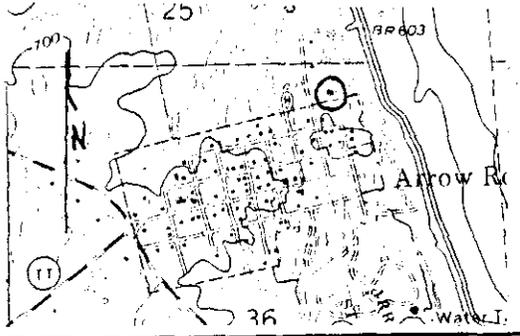
1 No 91		4 Present Name(s) Bill Cole Residence	
2 County Saline		5 Other Name(s)	
3 Location of Negatives Friends of Arrow Rock			
6 Specific Location Located just to the N of the city limits along 1st St should it be extended it		16. Thematic Category	
7 City or Town If Rural, Township & Vicinity Arrow Rock vicinity		17 Date(s) or Period pre 1870's	
8 Site Plan with North Arrow

42. Further Description of Important Features Built on a two room saddlebag form with a central chimney the residence show some evidence of an addition on the NE corner however nothing remains presently. The original 6-6 windows are still intact. Wide vertical sheathing is evident under the clapboarding.		31. Wall Construction heavy timber frame	
43 History and Significance Despite its poor conditions, both interior and exterior, the residence is restorable. It is a prime example of the standard form of housing used in this area; and a rare example of one which retains its architectural integrity, with out new siding, and asphalt roof, etc. Since the last resident and the property owners are black, it could possibly offer historical information to their culture in Arrow Rock.		32. Roof Type & Material gable, wood sh.	
44 Description of Environment and Outbuildings There are no outbuildings. Another residence is immediately to the S of the structure. A well is between the two buildings.		33. No. of Bays Front 3 Side

45 Sources of Information Interview with Henrietta Rich, 6-79		34. Wall Treatment walnut clapboarding	
46. Prepared by L. Harper		35. Plan Shape rec	
47. Organization Friends of Arrow Rock		36. Changes (Explain in #42) Addition <input checked="" type="checkbox"/> Altered <input type="checkbox"/> Moved <input type="checkbox"/>	
48 Date 6-79		37 Condition Interior deteriorating Exterior DOOR	
49 Revision Date(s)		38. Preservation Underway? Yes <input type="checkbox"/> No <input checked="" type="checkbox"/>
